THE GEORGE HOTEL, RYE

EXTERIOR PAINTWORK

Samples were taken from the windows, doors and walls of the High street elevation and the lion street elevation, as listed on p.18

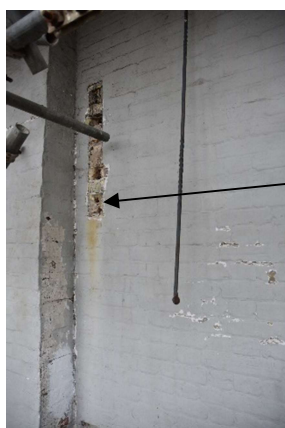
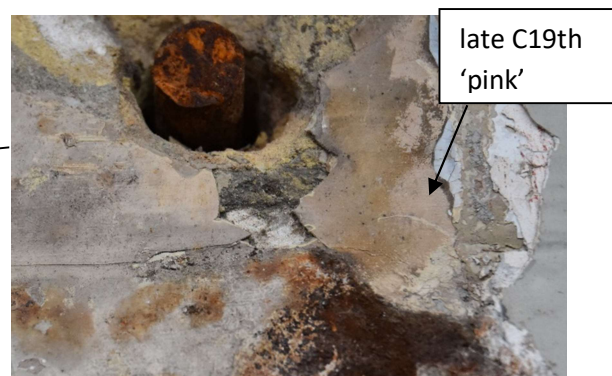
Where a fitting has been removed from the Ballroom wall, the pinkish colour of one of the last of the nineteenth-century schemes has been revealed

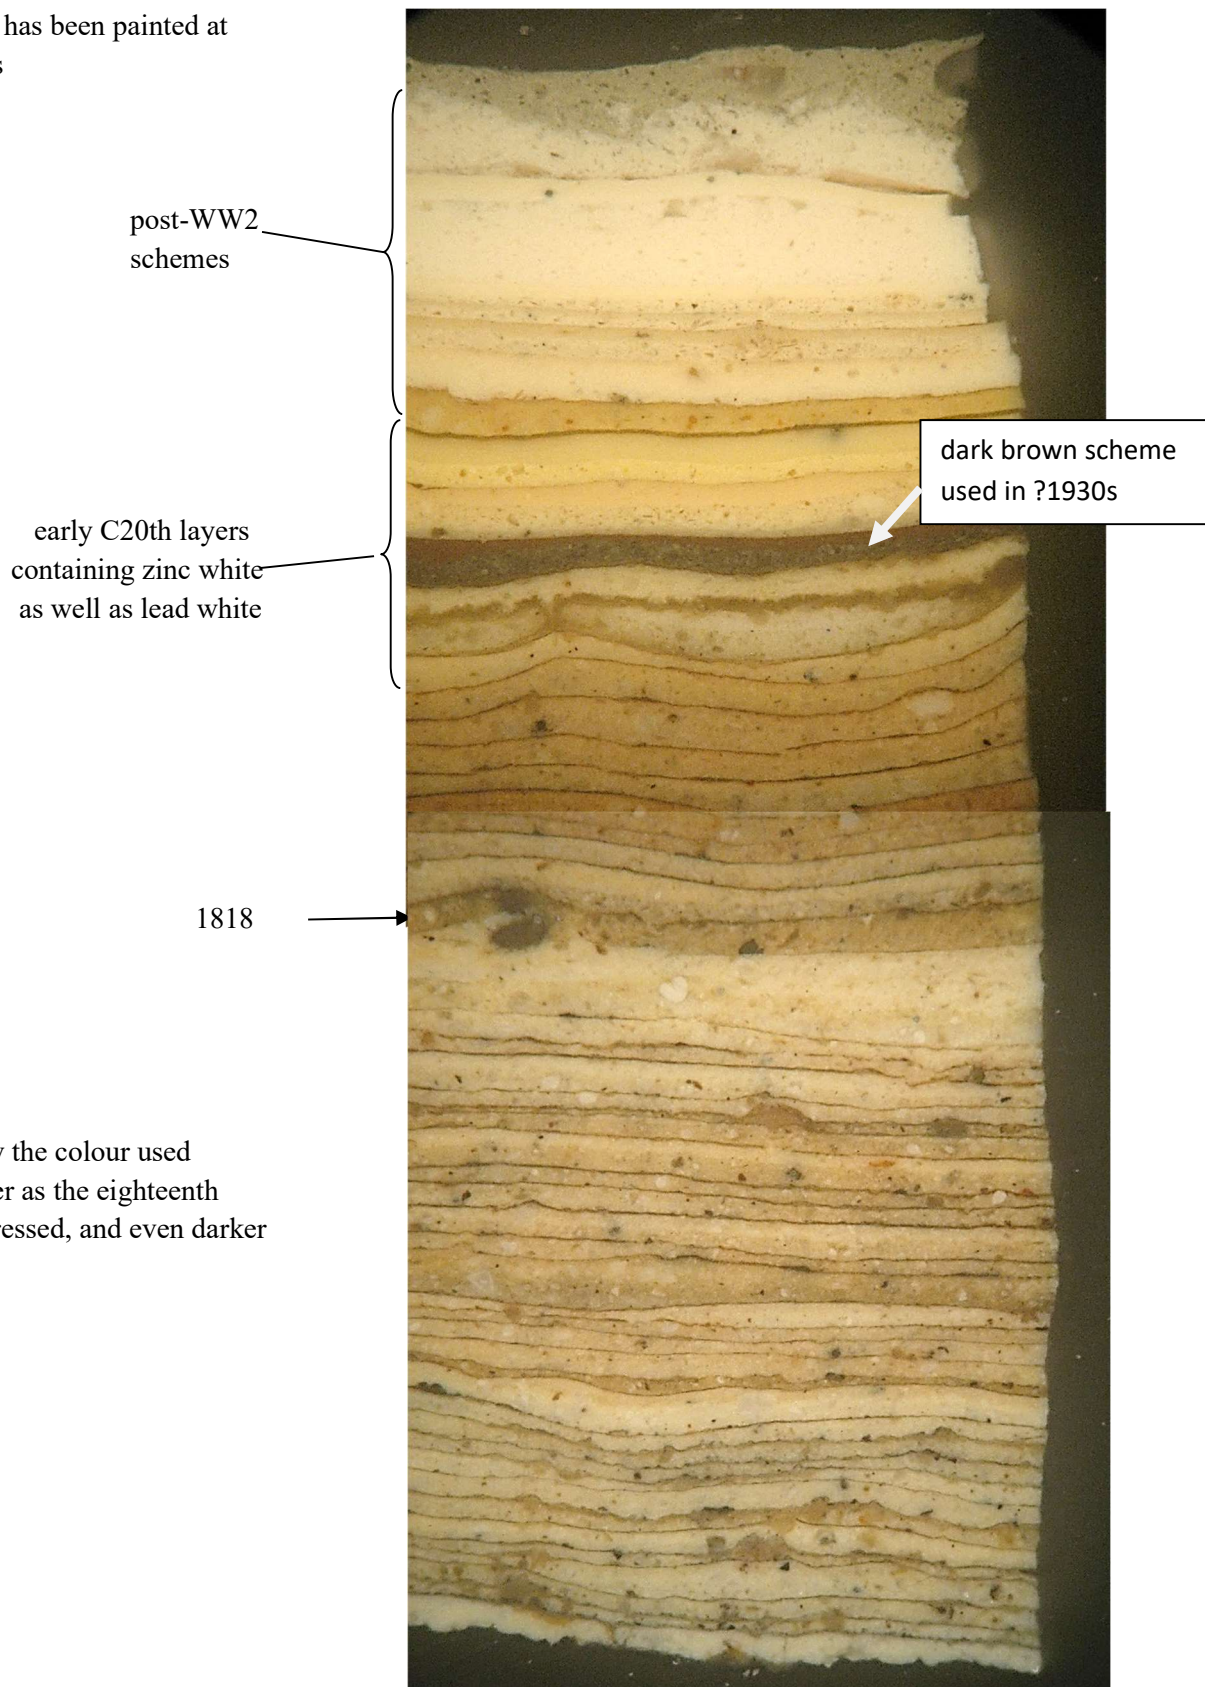
SAMPLE B1

Following the refurbishment parts of the exterior have been repainted more than fifty three times, which is approximately once every five or six years [see Sample B1, p.9].

Easternmost dormer window – facing High Street

Some of the later C20th layers are missing, otherwise the sequence is complete from C18th to the present day

This window has been painted at least 53 times

Showing how the colour used became darker as the eighteenth century progressed, and even darker after 1818

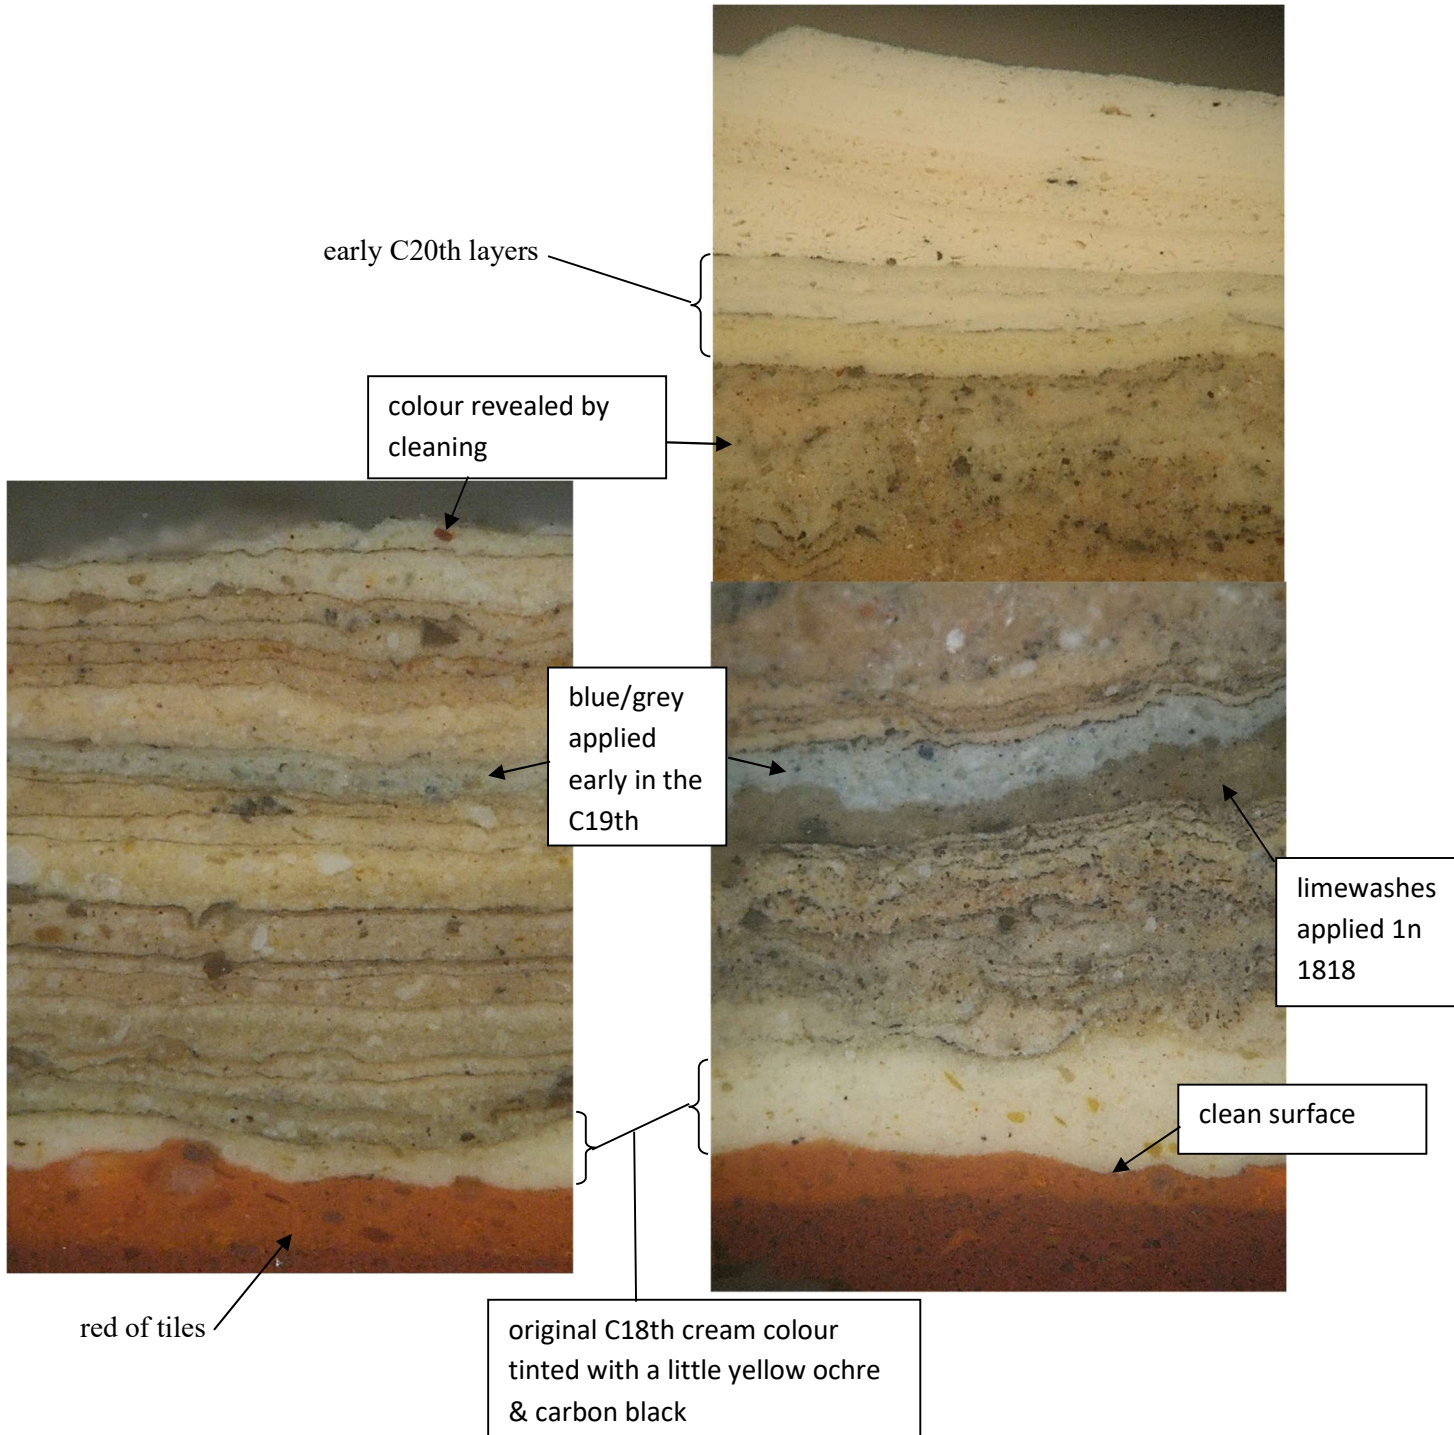
SAMPLE B4

The building was faced with mathematical tiles, which were fired with a dark red slip coat, but these tiles must have been painted soon after the building was completed, as no obvious layer of dirt can be seen between the terracotta and the first paint [Sample B4, p.10].

Wall at first floor level – all layers

The original cream-coloured oil paint sits on a clean tile surface, and must have been applied soon after building was completed.

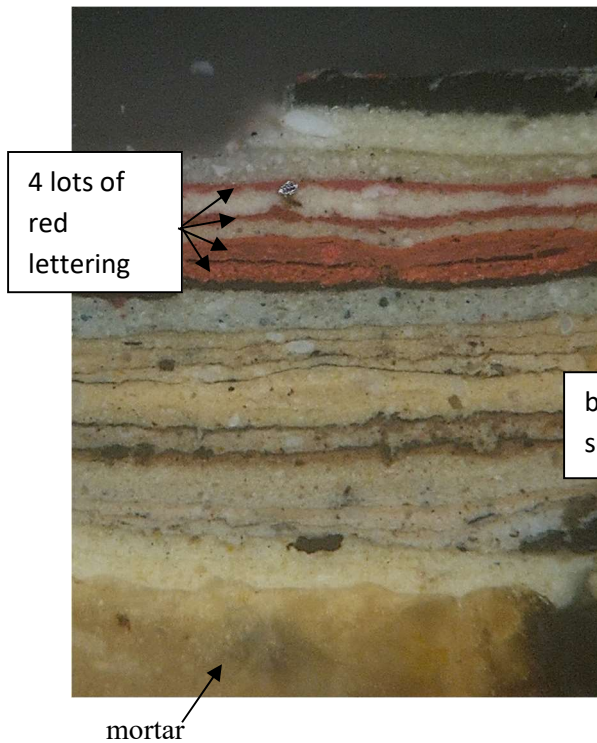
SAMPLE B10

Red lettering of word 'Hotel'

4 lots of red lettering

late C19th black

blue/grey applied soon after 1818

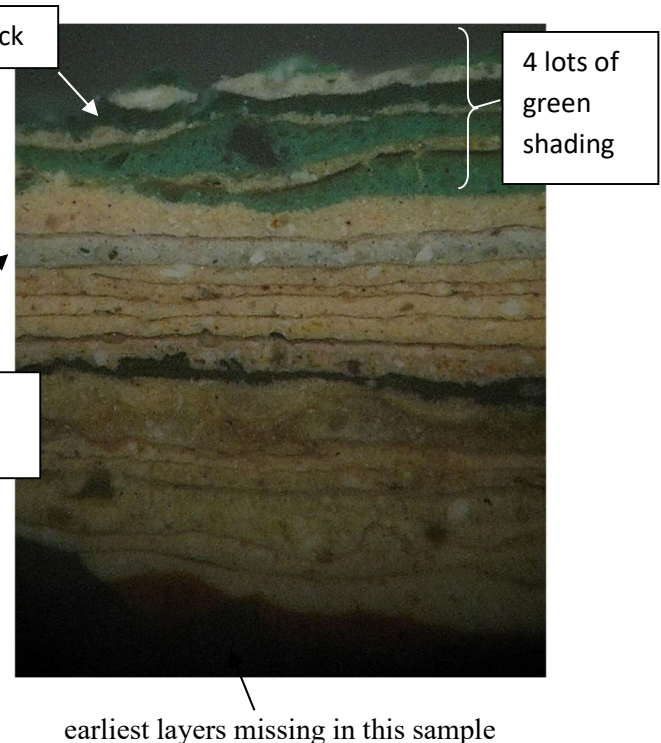
SAMPLE B11

Green shading of word 'Hotel'

4 lots of green shading

earliest layers missing in this sample

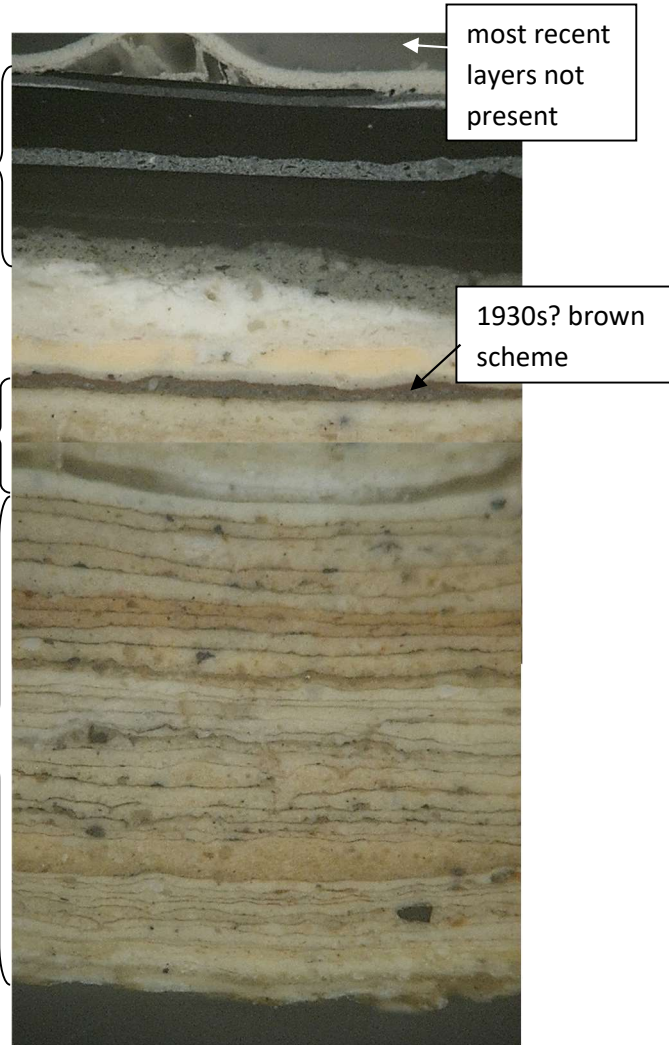
SAMPLE B16

Sash window – top floor

Showing that the window was painted a cream colour or stone colour, until the mid C20th

most recent layers not present

late C20th black schemes

1930s? brown scheme

early C20th layers contain zinc white

C18th & C19th layers

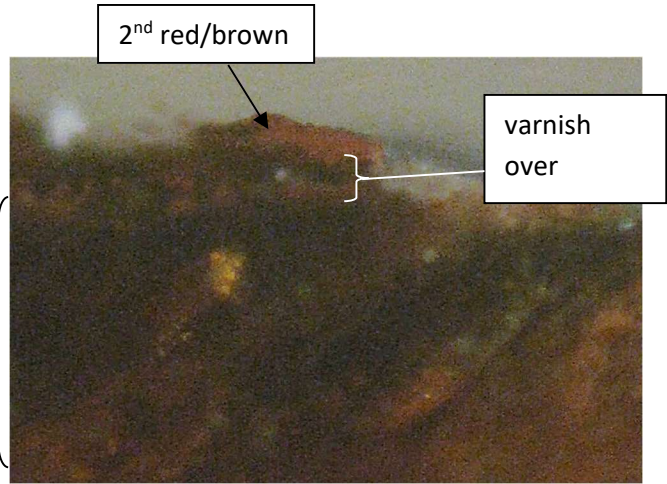
SAMPLE B21

The porch columns have been vigorously stripped, and very little early paint has survived, but one paint sample did have remains of a red/brown oil paint with a varnish finish [Sample B21, p.12]. It is not possible to be certain that this is eighteenth century paint, but it is certainly an early finish, and the columns are clearly still a dark colour in the 1860s photograph.

Porch column

traces of original brown have survived the paint stripping

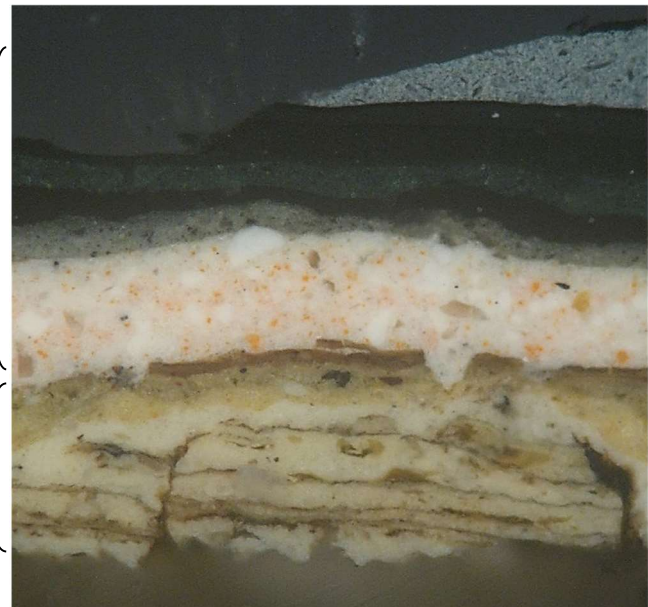
SAMPLE B24

No evidence was found for treatment of the doors themselves, but the doorcase for the front door at ground floor level [Sample B24, p.12], and the pedimented doorcase situated on the balcony were painted the same cream colour as the walls and windows.

Door case of front door

late C20th/C21st blacks applied after paint stripping

remains of early stone-coloured paints

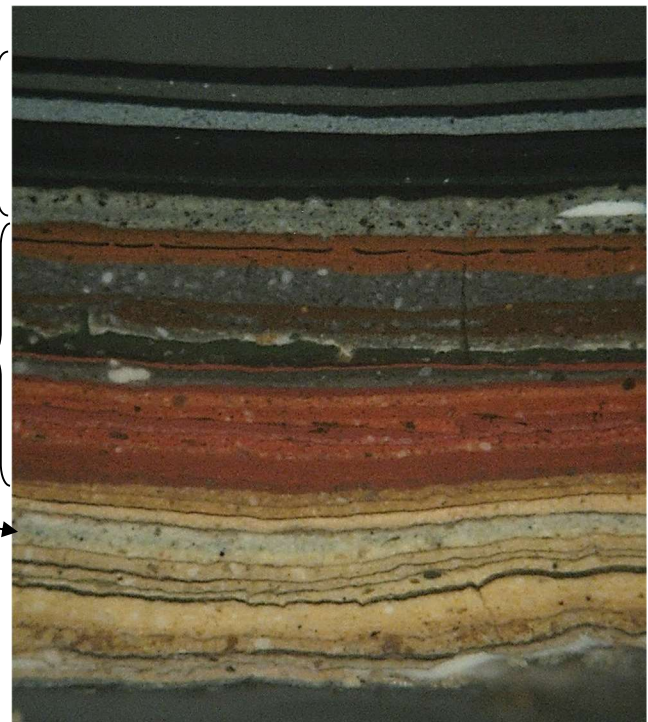
SAMPLE B29

Plinth to left of front door

Showing that the practice of painting the plinth a dark colour started after 1818

late C20th & C21st blacks

late C19th/early C20th browns

blue/grey applied soon after 1818

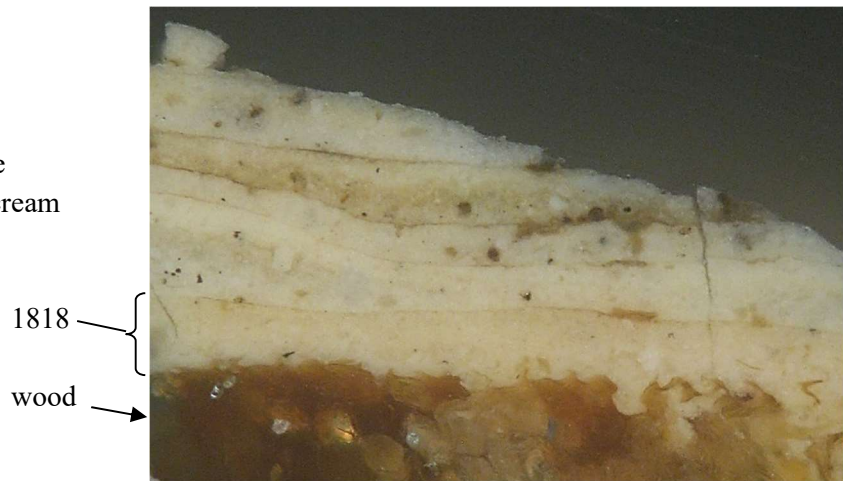
SAMPLE C3

Bow window of Ballroom

Later layers stripped off, but the fragment shows a sequence of cream colours used in early days

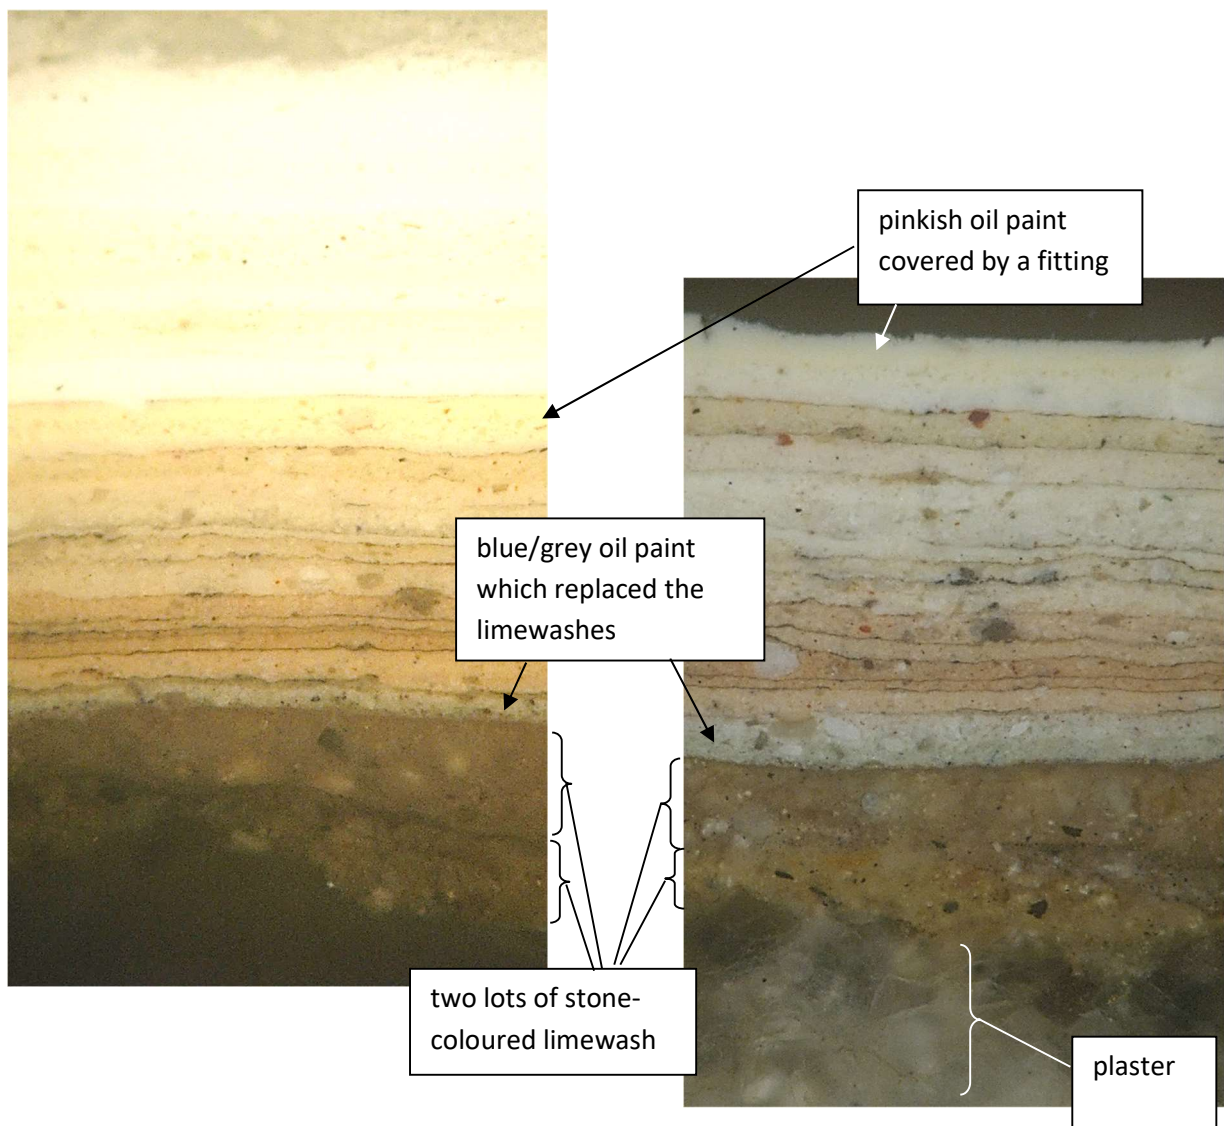
When the Ballroom was built, the walls of the whole Hotel on this elevation were painted with the same stone-coloured limewash [Sample C6, p.13]. These layers were only found in a few samples from the older part of the building, and they must have later been washed off, but they can be seen in Sample B4 [p.10].

SAMPLE C5

Wall of Ballroom

SAMPLE C6

Wall where fitting removed

Samples showing the early limewash schemes applied after 1818

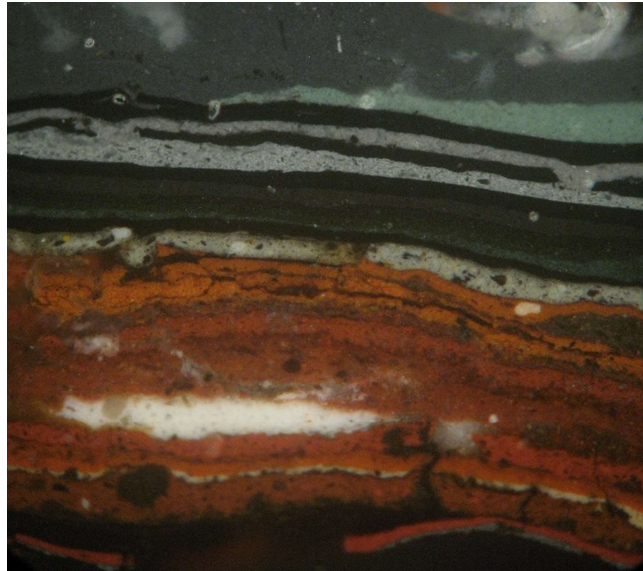
SAMPLE C11
Iron gutter fixing

The same red/brown was also used for the rainwater goods [Sample C11, p.14].

C20th back schemes

C19th & early
C20th browns

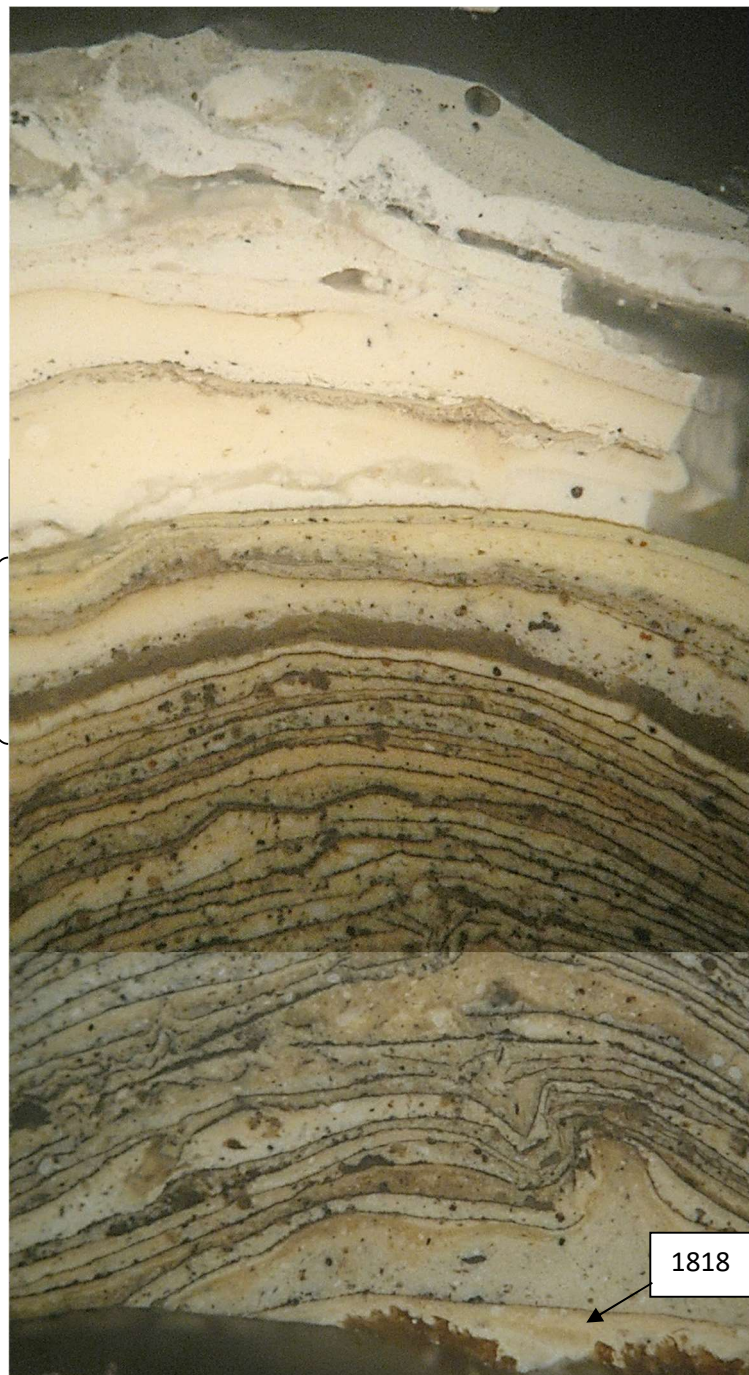
SAMPLE C12
Wooden cornice

The full sequence of paints
applied since
1818

Showing that the colour
was much darker in the
later C19th

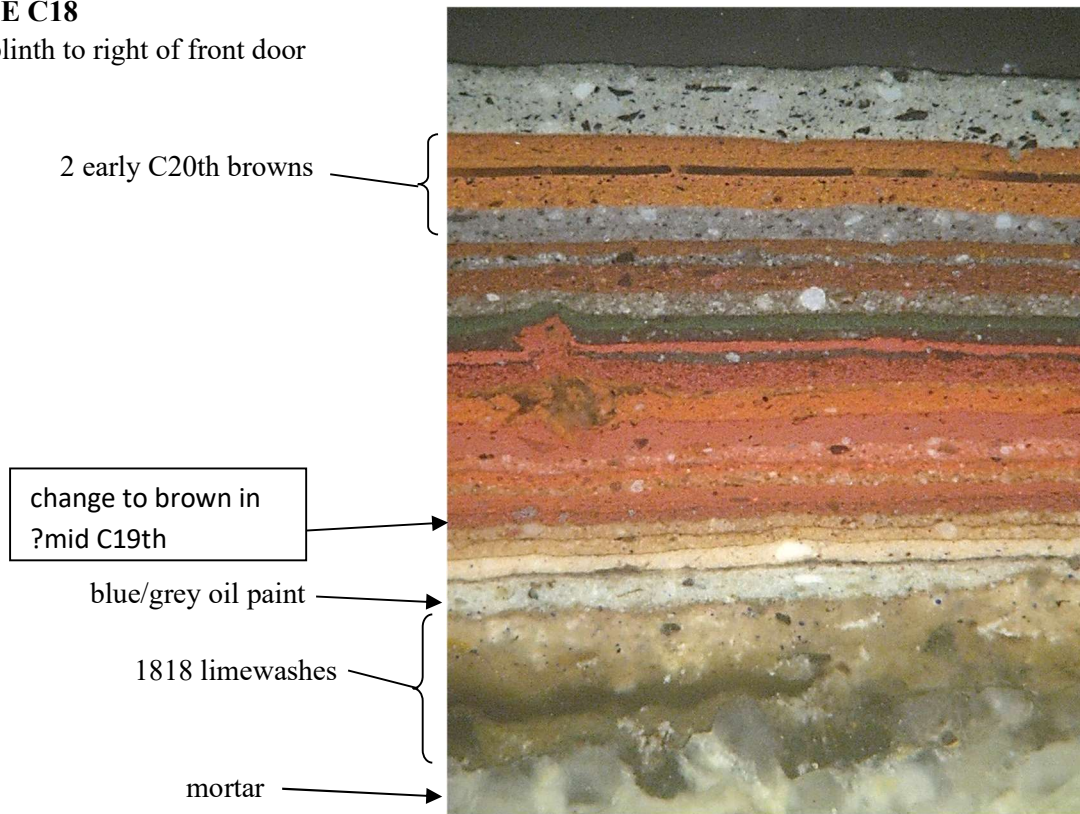
SAMPLE C18

Fictive plinth to right of front door

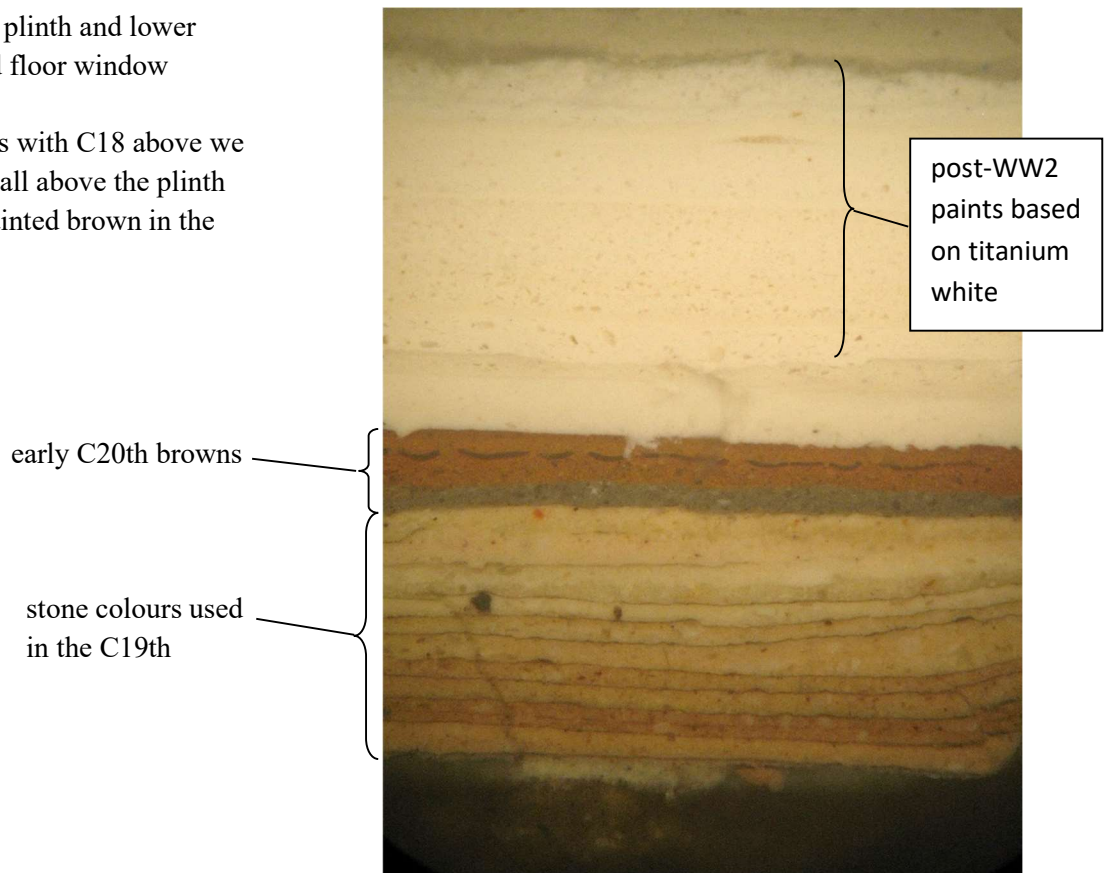
SAMPLE C26

There was a change: on two occasions there was a departure from the normal decoration, and brown was used extensively over the whole Hotel. Perhaps this coincided with the change of ownership to Trust House Forte. Brown was used for the sash windows, dormer windows [B1, p.9], window sills, door cases, cornices and rainwater goods. It was also used for the walls up to shoulder level [Sample C26, p.15]. Above that the walls were painted an off-white

Wall between plinth and lower part of ground floor window

comparing this with C18 above we can see that wall above the plinth was briefly painted brown in the early C20th

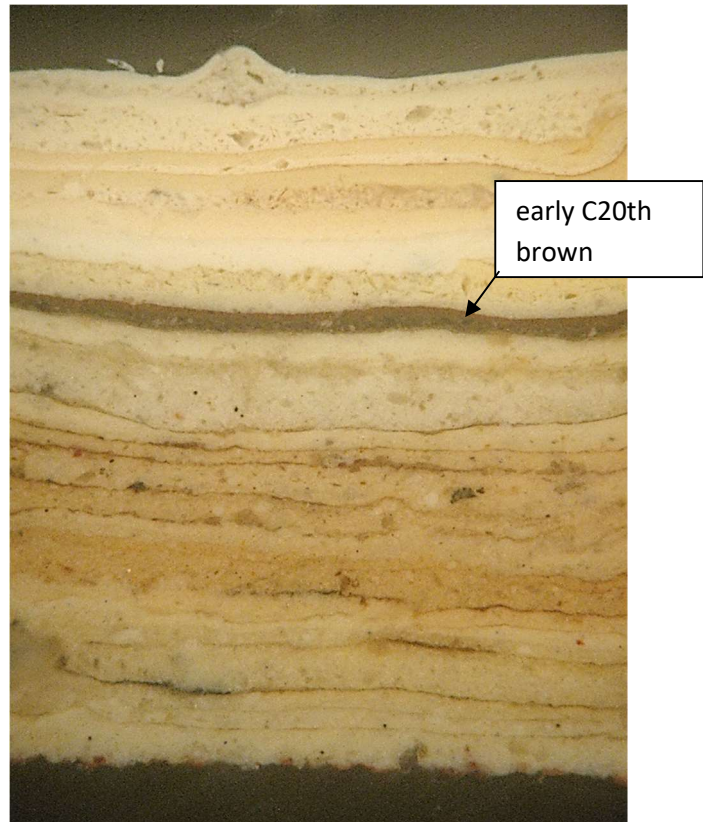
SAMPLE A1

The moulded cornice was painted the same as the cornices on the High Street, i.e. with cream coloured, and stone coloured oil paints.

Lion Street, north – ground floor
'cornice'

Showing that apart from once in the early C20th, the cornice has always been painted the same cream and pale stone colours as the front of the building

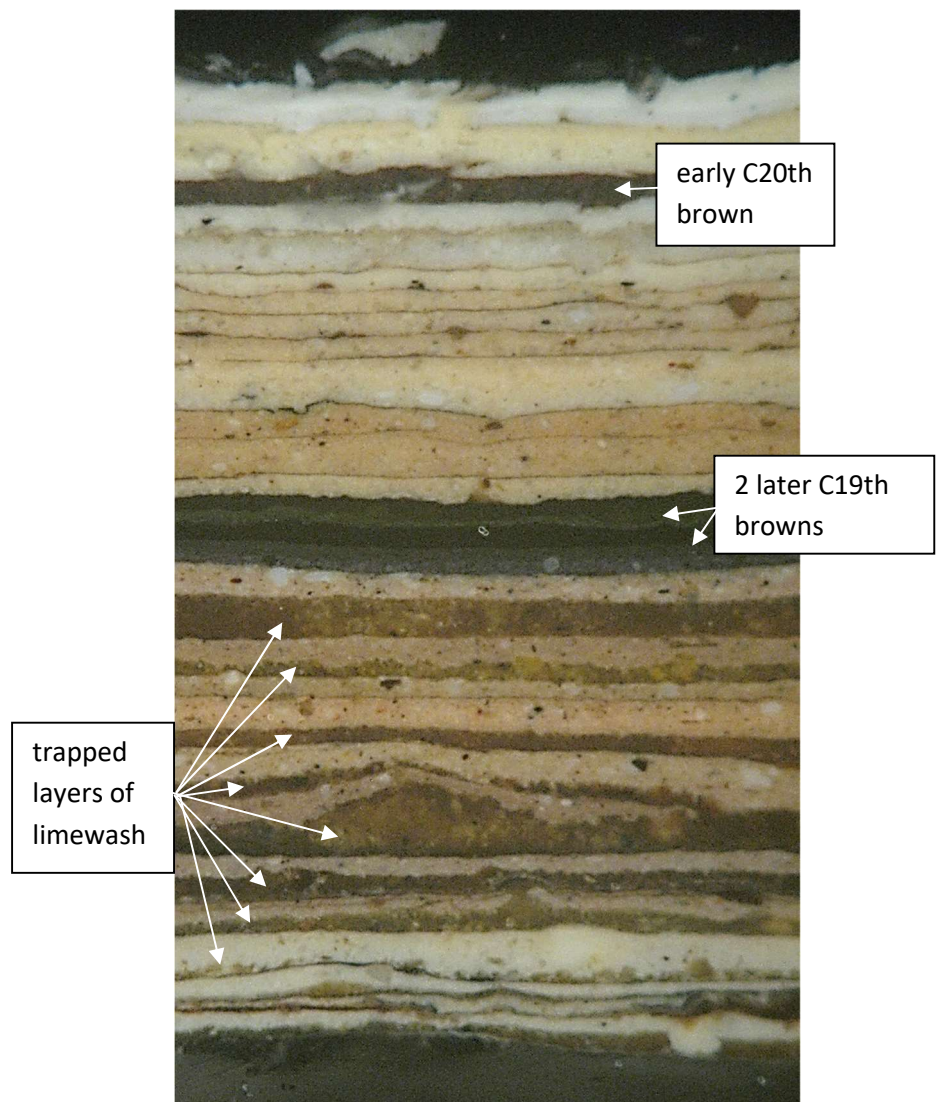
**SAMPLE A10**

Only twentieth-century paints were found in samples taken from the rendered walls, but in one sample from the side of the door architrave we can see layers of limewash sandwiched between layers of oil paint used for the door, and the facade of this part of the building must have been limewashed through the nineteenth century.

Lion Street, south –
side of door
architrave

The door architrave has mostly been painted cream or stone-colour.

The oil paints used for the architrave have trapped layers of limewash used for the rendered walls in the earlier C19th

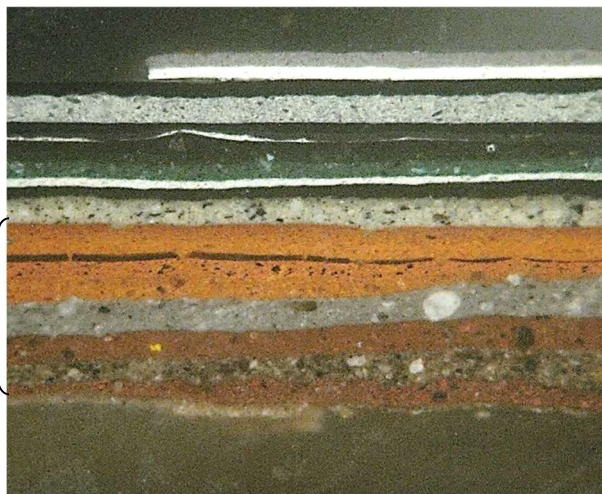
SAMPLE A9

Fictive plinth

Nineteenth-century layers are missing, and the sequence starts with early C20th brown schemes

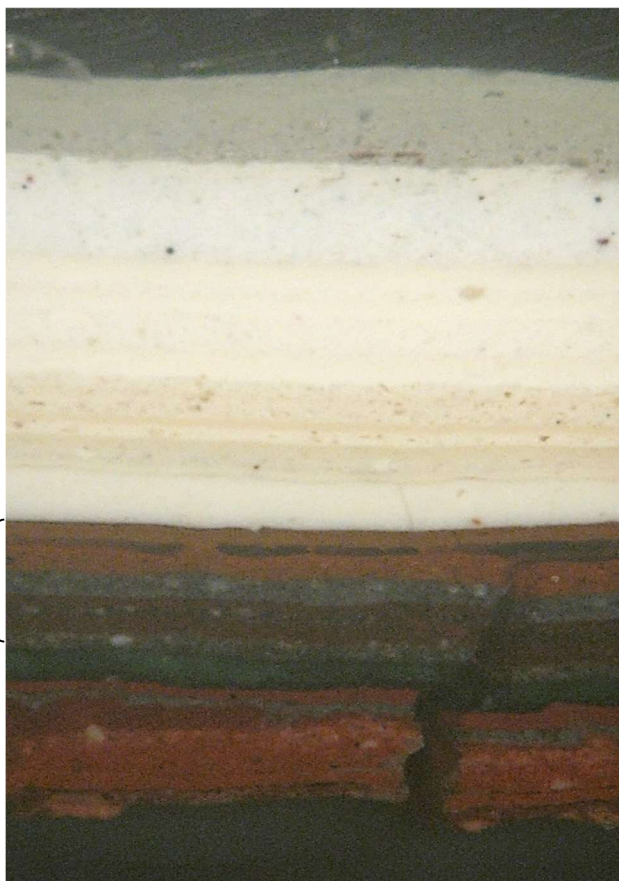
SAMPLE A13

The wall at this end of the building was being painted with reddish brown oil paints [Sample A13, p.17]. These paints were difficult to date, as they were based on iron oxides, but there were so many that they must go well back into the nineteenth century. They were presumably being painted to imitate brick or tile. No trace of the stone colours used on the High Street façade were found.

Lion Street, north – wall

same
browns as used on plinth
[see above]

5 C19th browns and a
dark green
