THE GEORGE HOTEL, RYE

EXTERIOR PAINTWORK

Samples were taken from the windows, doors and walls of the High street elevation and the lion street elevation, as listed on p.18

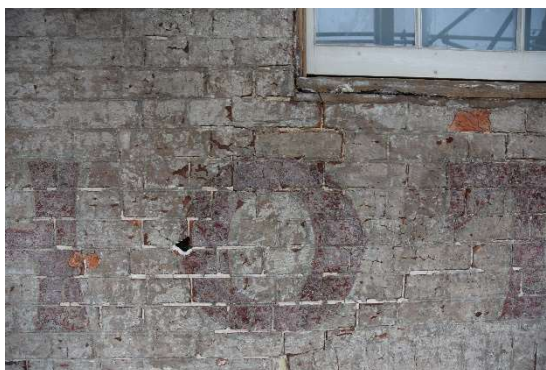
This coincided with the first time that 'GEORGE HOTEL' was painted across the façade using a red for the letters and green for the shading [Sample B10, p.11].

The red was a pure red ochre, the green a mixture of Prussian blue and chrome yellow.

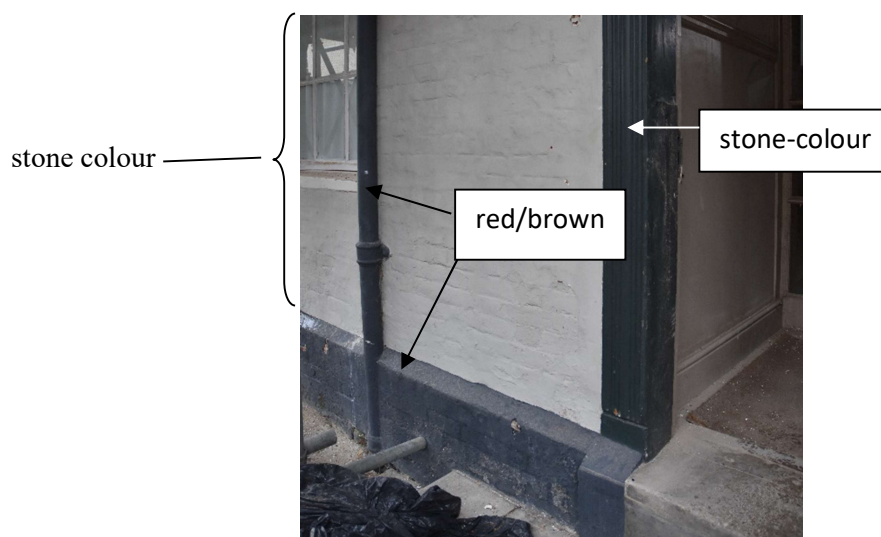
Coinciding with painting 'GEORGE HOTEL' was the decision to now paint the plinths a dark reddish brown.

The same red/brown was also used for the rainwater goods [Sample C11, p.14].

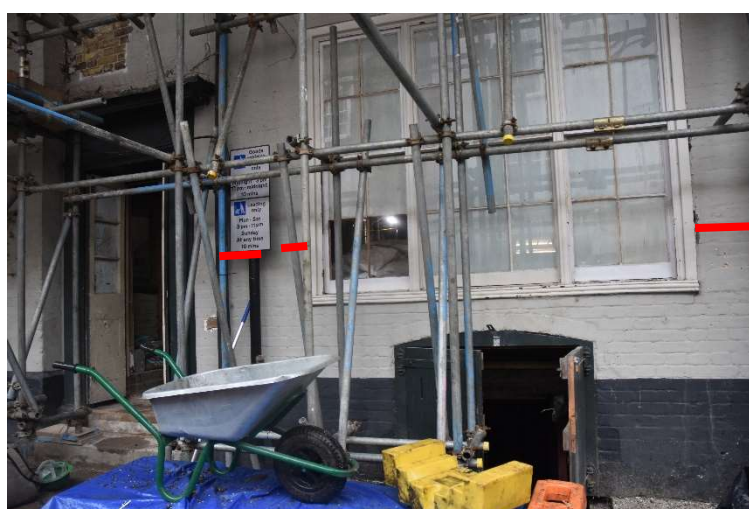
There was a change: on two occasions there was a departure from the normal decoration, and brown was used extensively over the whole Hotel. Perhaps this coincided with the change of ownership to Trust House Forte. Brown was used for the sash windows, dormer windows [B1, p.9], window sills, door cases, cornices and rainwater goods. It was also used for the walls up to shoulder level [Sample C26, p.15]. Above that the walls were painted an off-white

Painted off-white

Painted brown

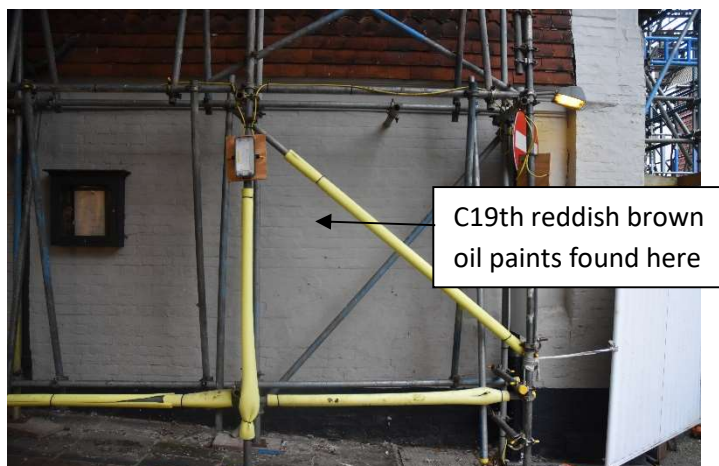
Building at far north end

The wall at this end of the building was being painted with reddish brown oil paints [Sample A13, p.17]. These paints were difficult to date, as they were based on iron oxides, but there were so many that they must go well back into the nineteenth century. They were presumably being painted to imitate brick or tile. No trace of the stone colours used on the High Street façade were found.

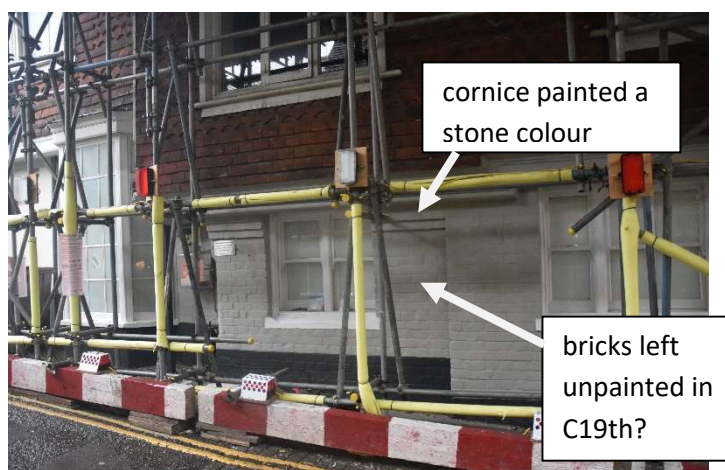
Building with moulded cornice

The moulded cornice was painted the same as the cornices on the High Street, i.e. with cream coloured, and stone coloured oil paints.

Only twentieth-century paints were found on the wall itself and the samples show that the surface of the bricks has thick dirt on it, so these bricks may have remained unpainted until recently.

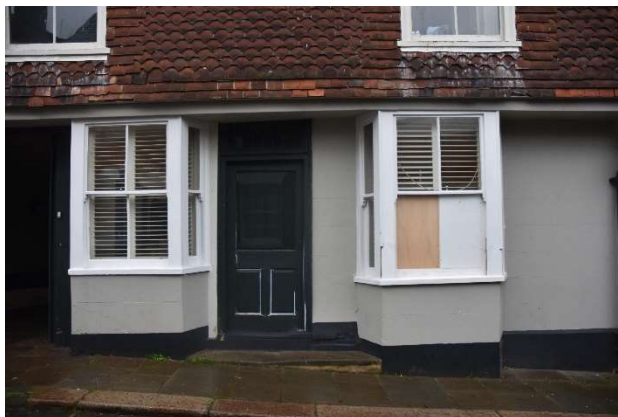
Building at north end with rendered facade

Only twentieth-century paints were found in samples taken from the rendered walls, but in one sample from the side of the door architrave we can see layers of limewash sandwiched between layers of oil paint used for the door, and the facade of this part of the building must have been limewashed through the nineteenth century.

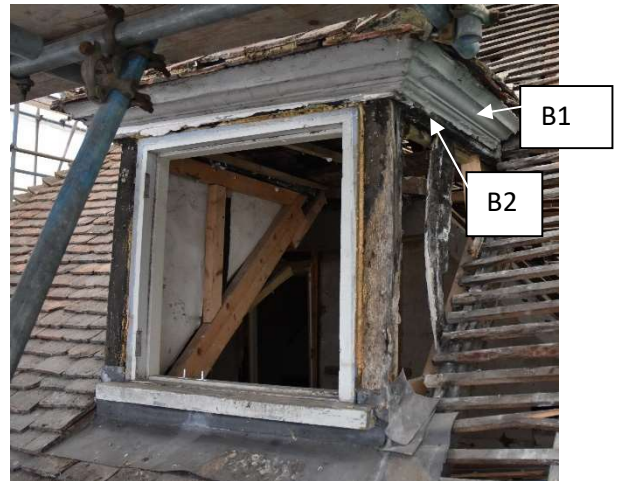
Dormer window, east end

- B1 moulding above window
- B2 remains of render on west side of dormer

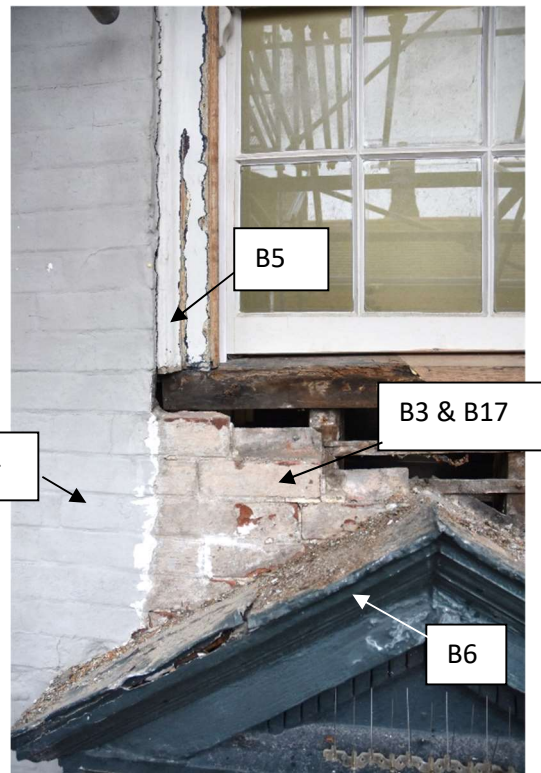
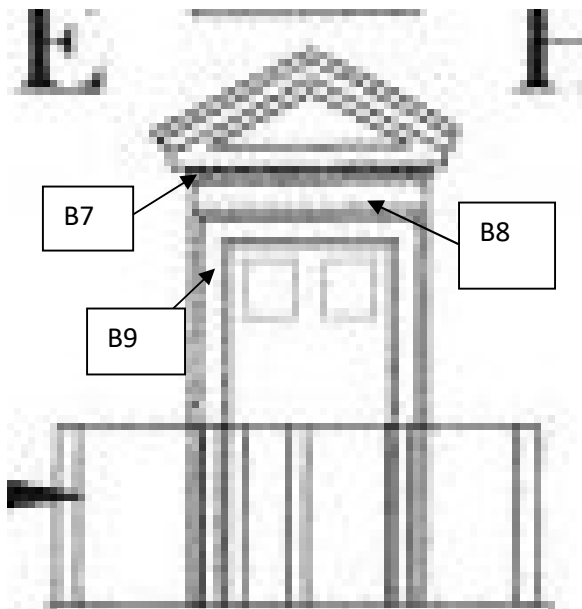
Second floor central window & door

- B3+17 cleaned area of wall
- B4 uncleaned area of wall
- B5 window frame
- B6 pediment
- B7 dentil below pediment
- B8 swag
- B9 door architrave

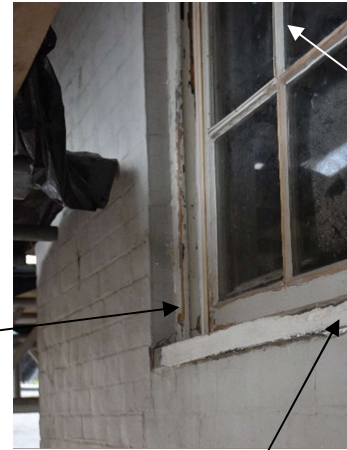
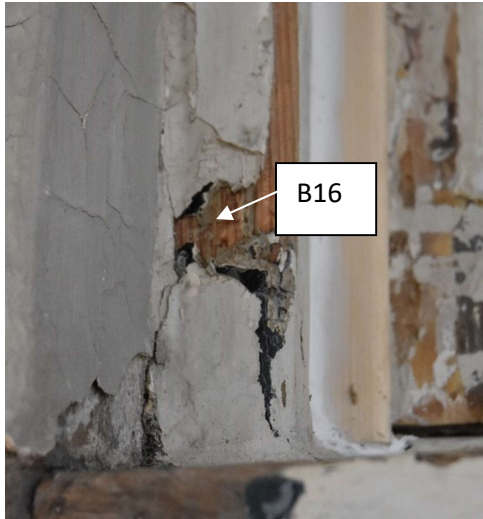
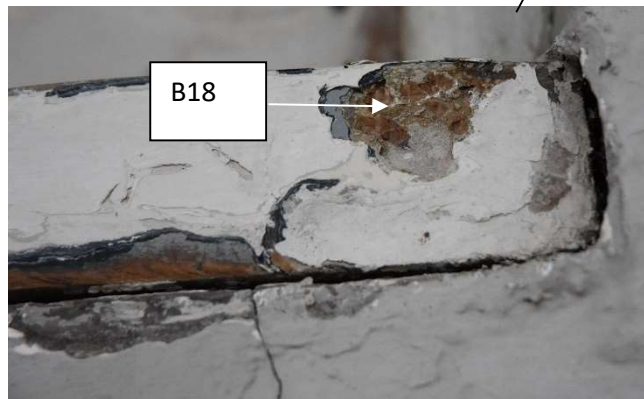
Second floor – far east window

- B16 window frame
- B18 sill

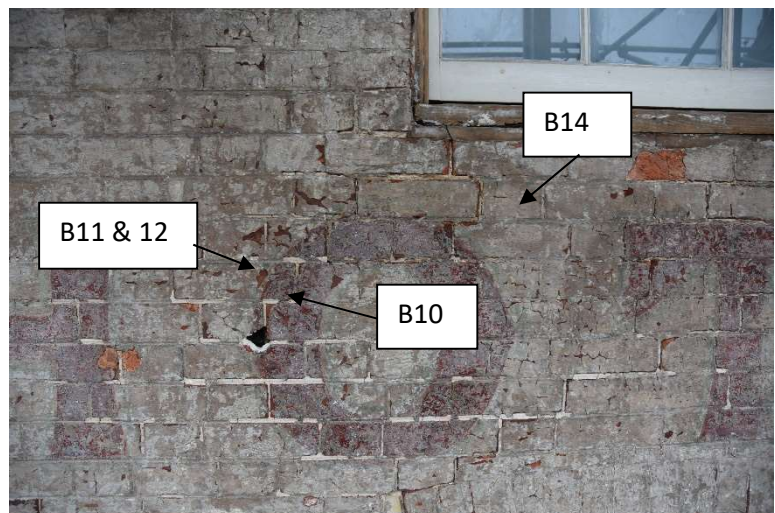
- 'HOTEL' sign
- B10 letter 'O' – red layers up to dark brown
- B11 letter 'O' – green layers
- B12 letter 'O' – layers over green
- B13 letter 'E' – uncleaned area [not shown]
- B14 cleaned background
- B15 uncleaned background, left of letters [not shown]

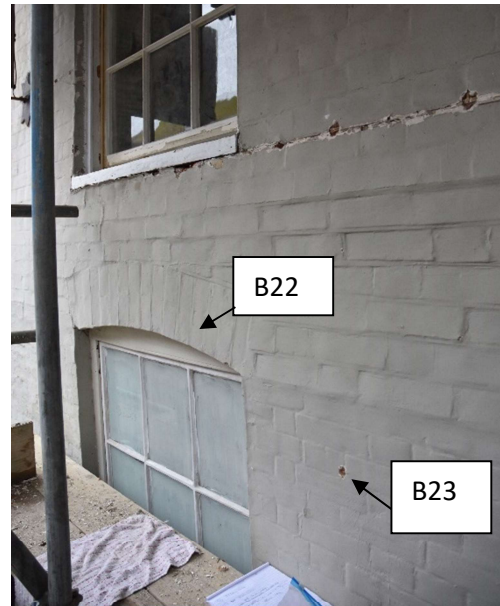
First floor level

- B22 Above window
B23 Between windows

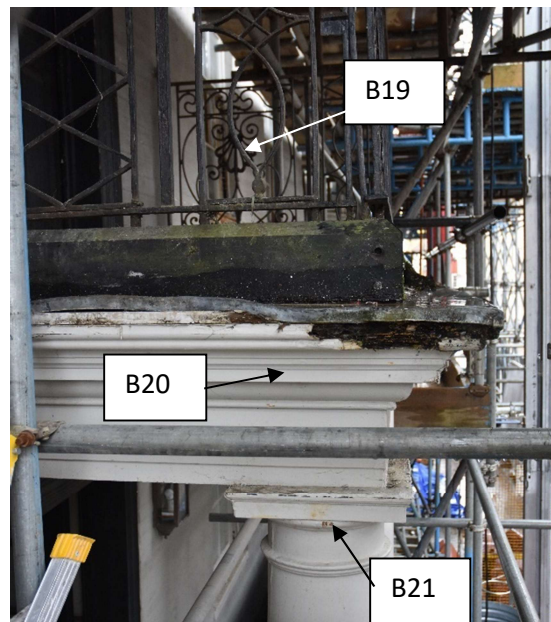
Porch & Balcony

The porch columns have been vigorously stripped, and very little early paint has survived, but one paint sample did have remains of a red/brown oil paint with a varnish finish [Sample B21, p.12]. It is not possible to be certain that this is eighteenth century paint, but it is certainly an early finish, and the columns are clearly still a dark colour in the 1860s photograph.

- B19 railings
B20 porch cornice
B21 column capital

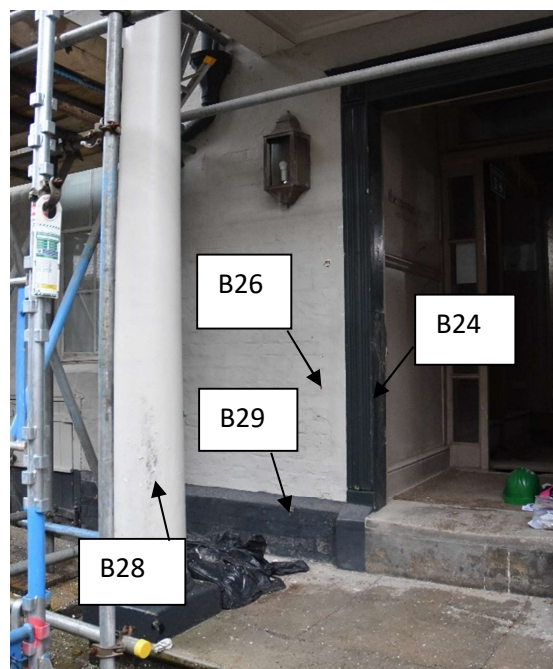
Ground floor

- B24 door case
B25 door [not shown]
B26 wall to east of door
B27 plinth at east end [not shown]
B28 porch column
B29 plinth to left of door

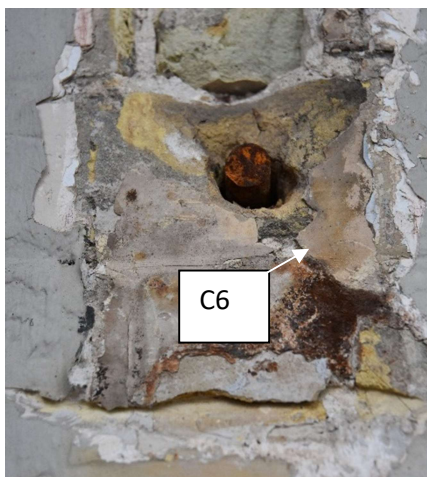
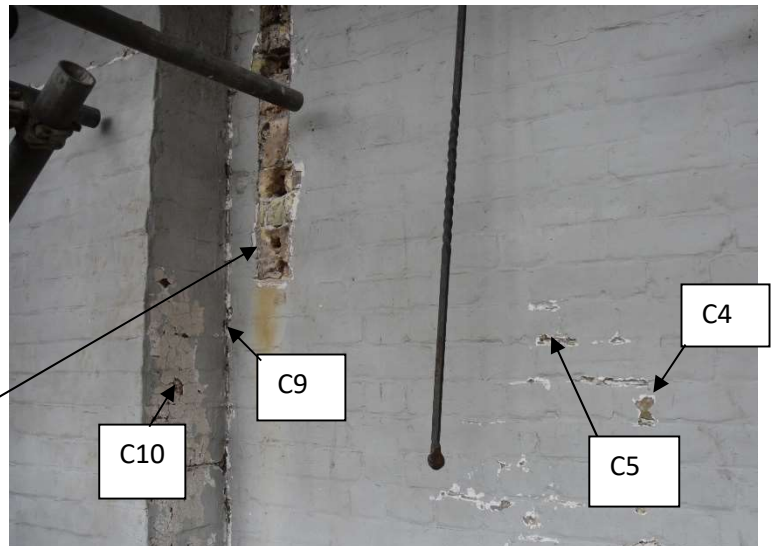
East end of Ballroom extension

Where a fitting has been removed from the Ballroom wall, the pinkish colour of one of the last of the nineteenth-century schemes has been revealed

- C4 layers on brick
- C5 layers on mortar
- C6 pink revealed where fitting removed
- C9 angle between buildings
- C10 return of main building

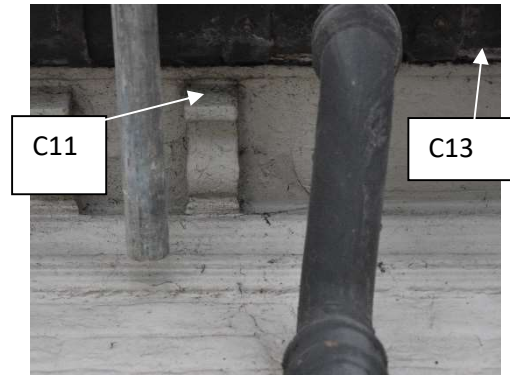
Cornice

- C11 iron gutter fitting [not shown]
- C12 modillion
- C13 gutter fascia board

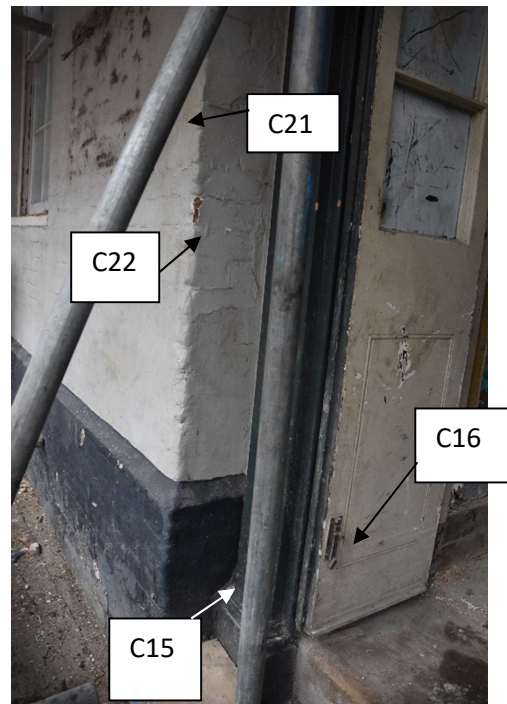
Ground floor – east end of Ballroom

- C15 door case
- C16 door
- C21 13th brick above plinth
- C22 9th brick above plinth

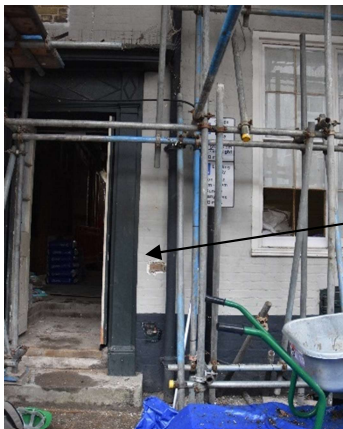
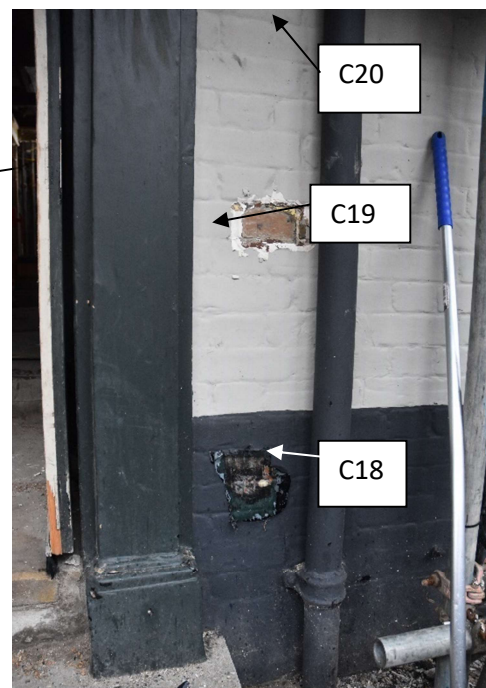
To west of Ballroom entrance door

- C18 fictive plinth on right
- C19 6th brick up from painted plinth
- C20 12th brick up from painted plinth

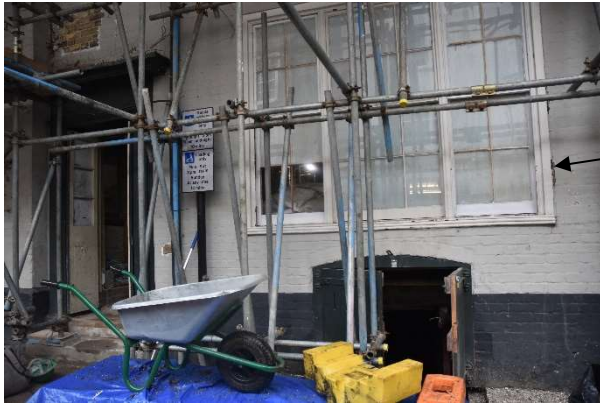
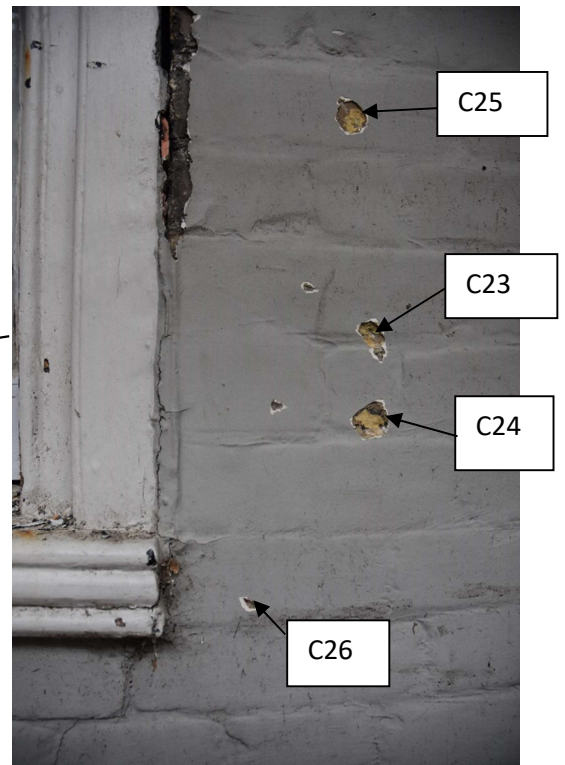
Wall to right of east window on Ballroom extension

- C23 4th brick up from sill
- C24 3rd brick up from sill
- C25 6th brick up from sill
- C26 brick below sill level

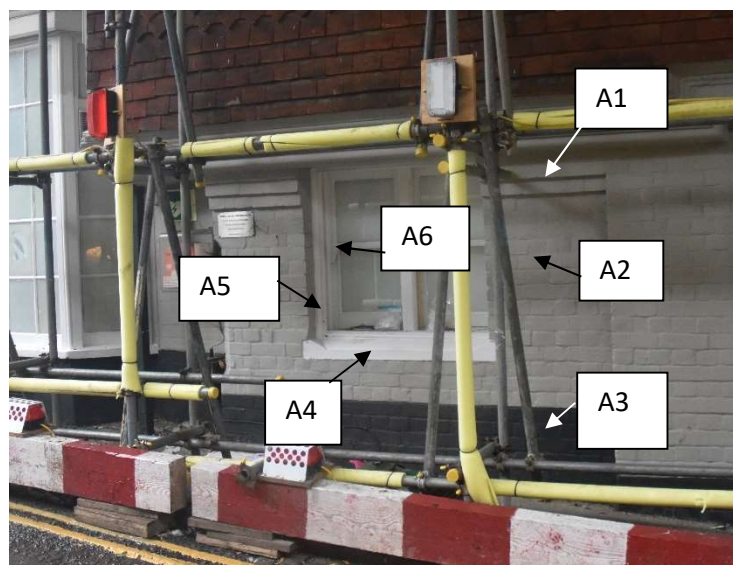
North end

- A1 moulded cornice
- A2 paint on tiles
- A3 fictive 'plinth'
- A4 window sill
- A5 window frame
- A6 window sash

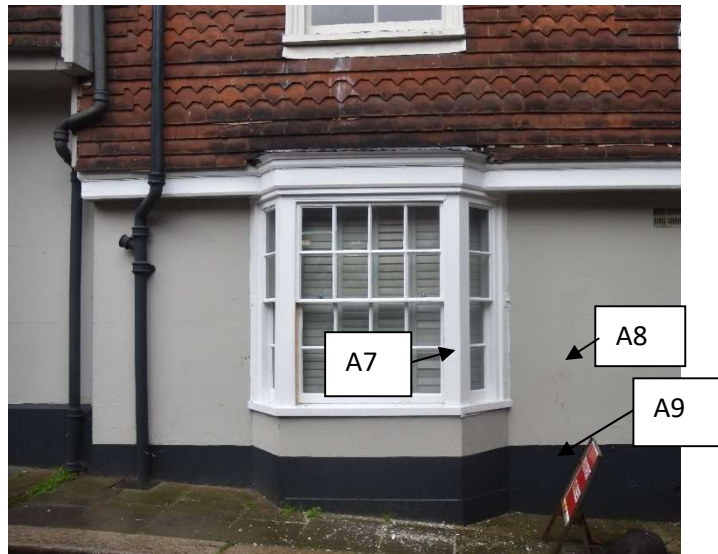
Second bay window from north end

- A7 window frame
- A8 rendered wall
- A9 fictive plinth

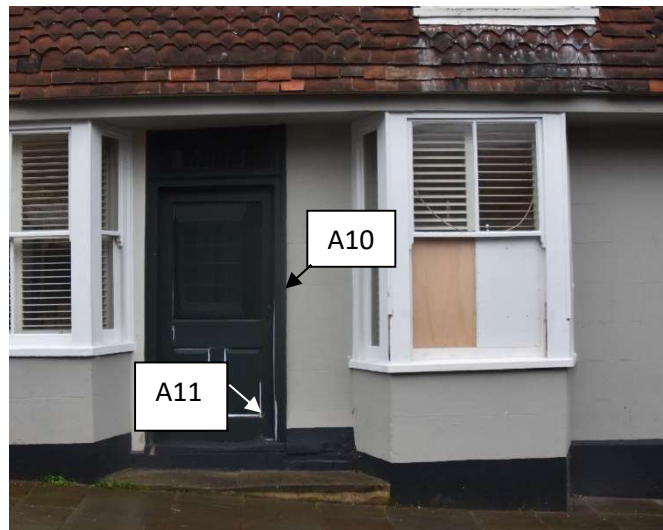
Door at south end

- A10 architrave
- A11 door

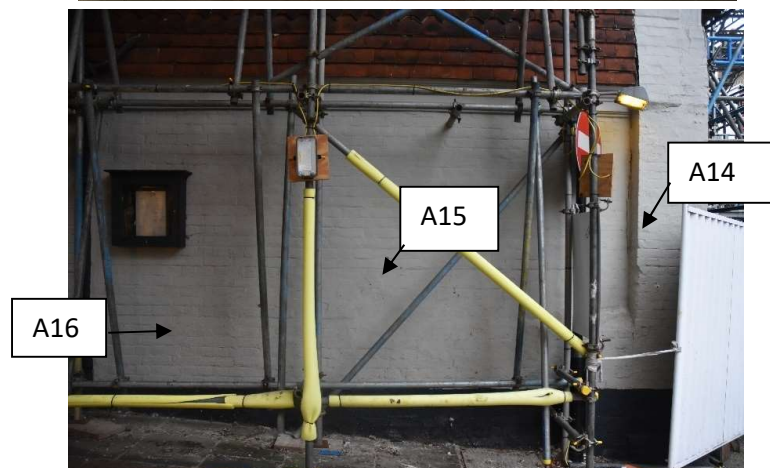
North end of Lion Street elevation

- A14 projecting end of wall
- A15 paint on ?tiles
- A16 paint on ?bricks
